### Conformal Coating Defects: When Things Go Horribly Wrong

By Pierce Pillon, Senior Field Engineer  
Webinar originally presented Sept. 2020.

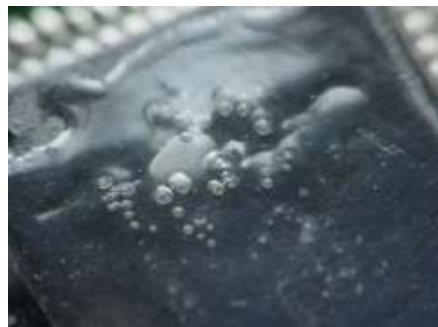
Fig 8

Bubbles are most often caused by solvent that becomes entrapped when it flashes off (evaporates). For whatever reason, the solvent vapor can't escape the coating, so the vapor creates a void within the coating that bulge out.
